## TECHNICAL SERVICE BULLETIN

### 5.0L - Oil Leaks From Valve Cover Gasket

**19-2309**  
16 October 2019

<b>Ford</b> 2015-2017 Mustang
----------------------------------

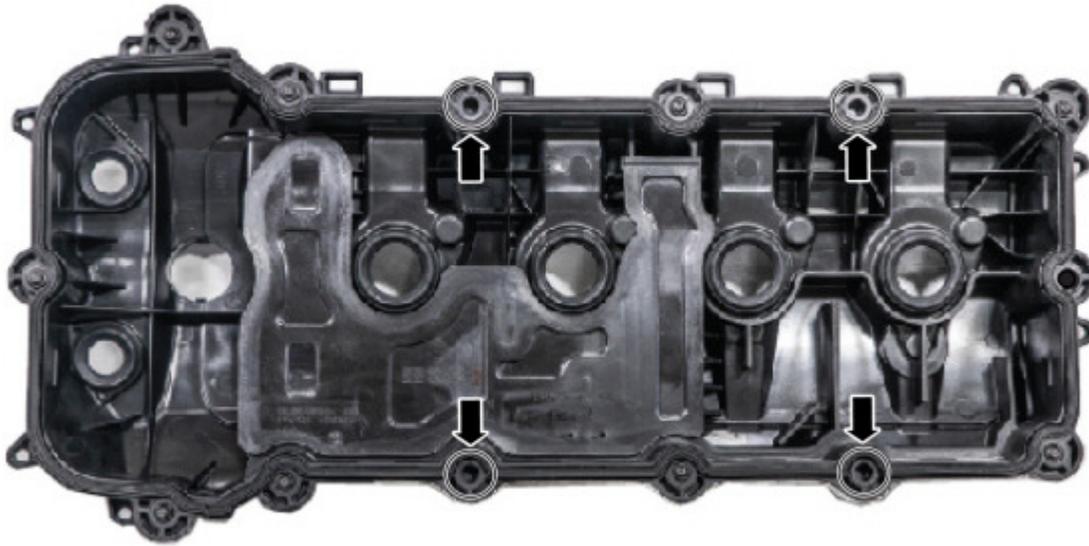
Figure 1

**Issue:** Some 2015-2017 Mustang vehicles equipped with a 5.0L engine may exhibit an oil leak from either valve cover gasket. This may be due to the valve covers warping due to excessive heat. To correct the condition, follow the Service Procedure steps to add fasteners to both valve covers.

**CAUTION:** Use a shop rag to prevent shavings from the drilling process from going into the under side of the valve cover. Thoroughly clean the under side of each valve cover after drilling to remove any shavings which may have entered into the under side of the valve cover. Any shavings left in the valve cover when it is reinstalled on the engine may enter the engine and cause damage to the engine.

2. Using a 10 mm (0.394 in) drill bit and drilling from the underside of the valve covers, drill holes through the tabs along the perimeter of the valve covers that do not already have holes, skipping over the tabs at the rear center of each valve cover. Following these instructions, each valve cover should require four holes to be drilled. This will allow fasteners to go through these tabs. Use the indented area on each tab as a guide to center the drill bit to make sure the holes are drilled in proper alignment to allow fasteners to pass through them and thread into the corresponding holes in the cylinder head when the valve covers are reinstalled on the engine. (Figure 1, right side shown, left side similar)
